**Facility Decommissioning Report and
Phase II Environmental Site Assessment
American National Can Company
1001 New Ford Mill Road
Morrisville, Pennsylvania**

August 18, 1997

**Prepared for
American National Can Company
8770 West Bryn Mawr Avenue
Chicago, Illinois, 60631**

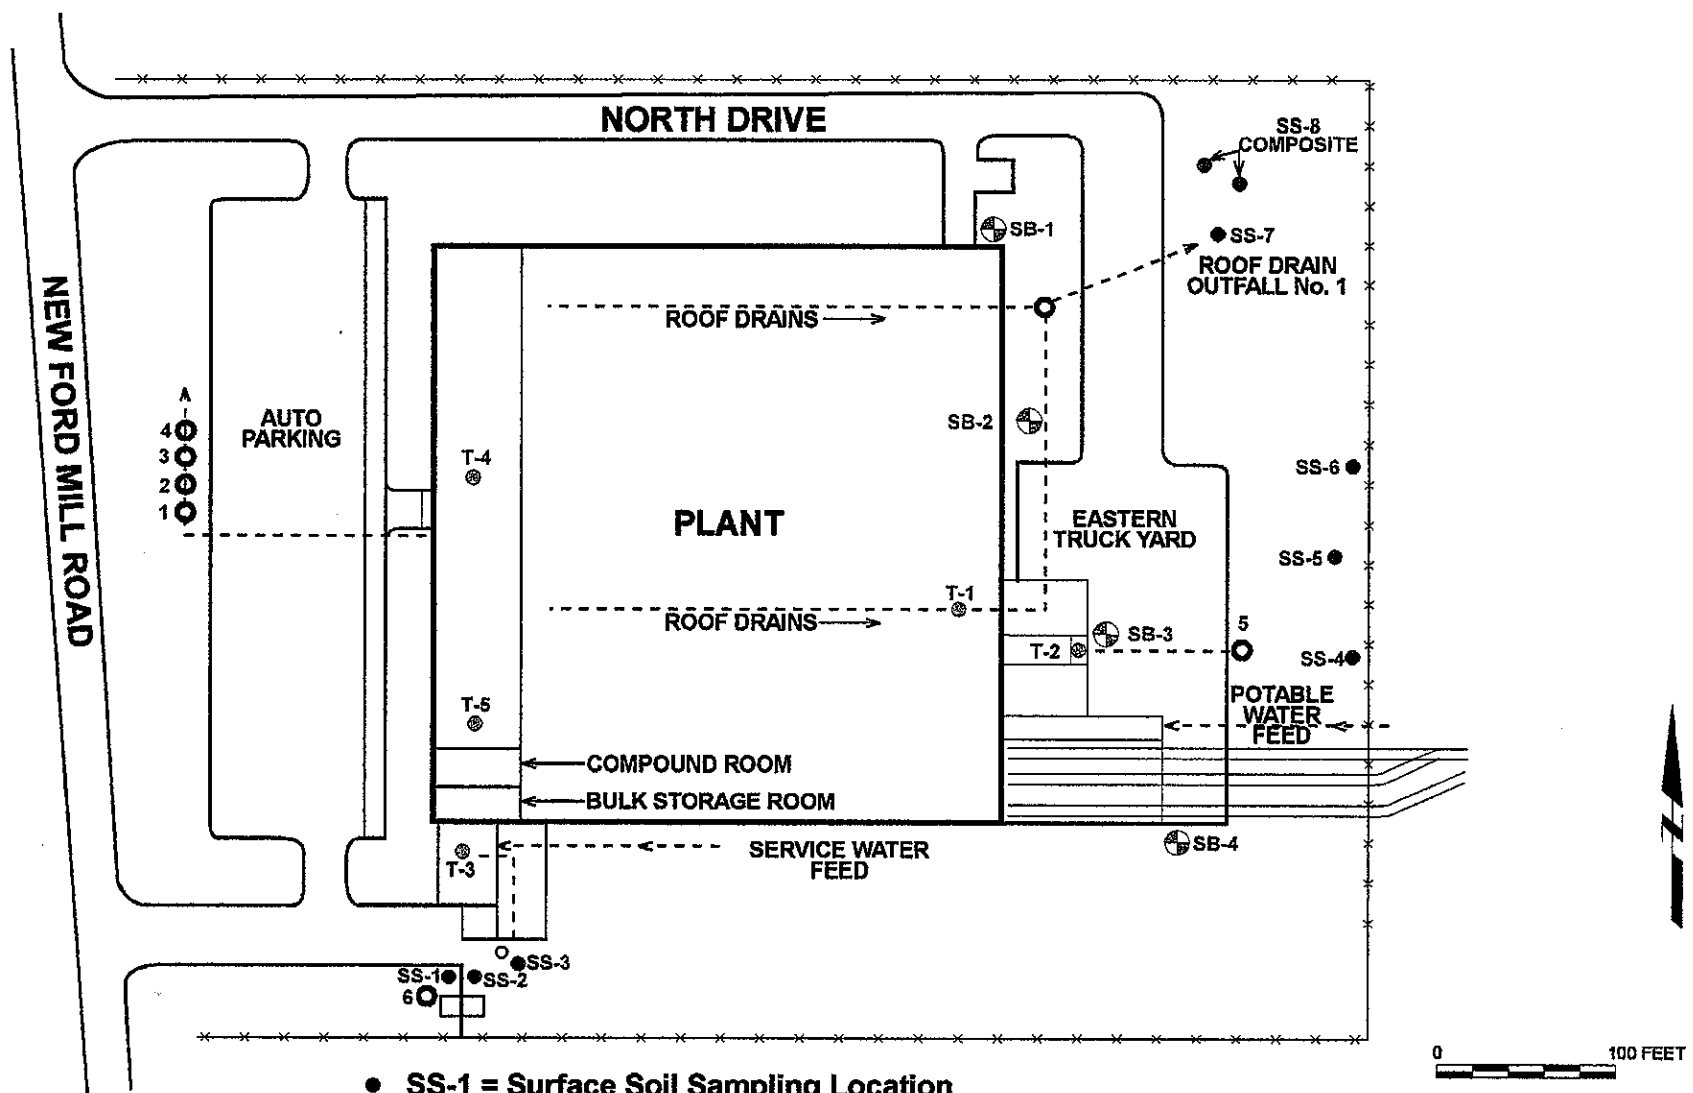
**Site Plan Showing
Sampling Locations**

The tracer/dye tests were inconclusive in determining the origin of water discharged to the manhole located near the outside transformer (manhole 6, Figure 2). This manhole consists of one concrete tank which measures approximately 8 feet deep by 6 feet in diameter. The tank contained approximately 3 feet of water and 1 foot of sludge. The sludge had a strong petroleum odor. The water level in the tank was too high to inspect for the presence of influent and effluent piping. One sample (TR-MH) was collected from the manhole located near the transformer.

Analysis results indicate that the sludge sample collected from the unidentified manhole contained total concentrations of arsenic, barium, cadmium, chromium, lead, and mercury exceeding RCRA Toxicity Characteristic Standards. Total concentrations of chromium and lead exceeded 20 times the RCRA Toxicity Characteristic Standard. Reanalysis of the samples using the TCLP method indicated that concentrations of RCRA metals are below the Toxicity Characteristic Standard, and thus the sludge is not a characteristic hazardous waste. In addition to the metals, 417 parts per million (ppm) and 2,460 ppm, respectively, of ethylbenzene and xylenes were detected in the sludge sample.

Three surface soil sample (SS-1, SS-2, and SS-3) were collected from the grassy and vegetated area located immediately south of the driveway that provides access to the front loading dock and drum storage pad (Figure 2).

Slightly elevated concentrations of various SVOCs, including isophorone, dimethyl phthalate, benzo (a) anthracene, benzo (b) fluoranthene, benzo (a) pyrene, indeno (1,2,3-cd) pyrene, and dibenzo (a,h) anthracene, were detected in the surface soil samples collected from the front loading dock area. In general, the detected concentrations exceeded Act II non-residential ingestion standards. These contaminants are often associated with construction fill and may also be associated with industrial activities in the general vicinity of the site and therefore, may represent background conditions.

One surface soil sample (SS-7) was collected from the downgradient edge of the ponded area at roof drain outfall No. 1 (Figure 2).

Analysis results indicate that the surface soil sample contained total concentrations of arsenic, cadmium, chromium, and selenium exceeding RCRA Toxicity Characteristic Standards and Act II soil to groundwater standards, but only chromium exceeded 20 times the RCRA Toxicity Characteristic Standard. The source of the detected constituents was not determined, but since the concentrations were significantly above the Act II soil to groundwater standards, the soil may be considered a potential source of groundwater contamination.

Three surface soil samples (SS-4, SS-5, and SS-6) were collected from along the eastern fence line (Figure 2). In addition, one composite surface soil sample (SS-8) was collected from two unvegetated areas located immediately north and northwest of roof drain outfall No. 1. The unvegetated areas appeared to be recently covered with fill material containing miscellaneous construction debris.

Arsenic, cadmium, and chromium concentrations in one or more samples collected from the rear fence line exceeded Act II soil to groundwater standards. The highest concentrations were detected in sample SS-8, which was collected from the two unvegetated areas. This sample appeared to be fill material containing pieces of rebar and other construction materials. Sample SS-8 also contained low concentrations of SVOCs which are often associated with construction fill and may also be associated with industrial activities in the general vicinity of the site.

Four soil borings were drilled along the eastern side of the building in and adjacent to the rear truck yard. Soil boring SB-1 was located in a stained soil area at the northeast corner of the building; the remaining three borings were randomly located along the eastern side of the building (Figure 2).

Concentrations of SVOCs and VOCs in the surface sample collected from boring SB-1 did not exceed Act II soil to groundwater standards. SB-1 was located outside the northeast corner of the building and was advanced through a stained soil area, apparently the result of surface oil spills. PID readings decreased with depth, indicating limited migration to the subsurface.

One groundwater sample (GW-Well) was collected at a depth of 30 feet from a 6-inch-diameter groundwater well located by the southern end of the drum storage pad (Figure 2). The sample was collected for preliminary screening of groundwater quality. Approximately one well volume of water was purged from the well prior to sampling.
